# 4.1. BARLINDALEN GRUVER

Kongsberg den 7/2-1978  
R. Kongsberg

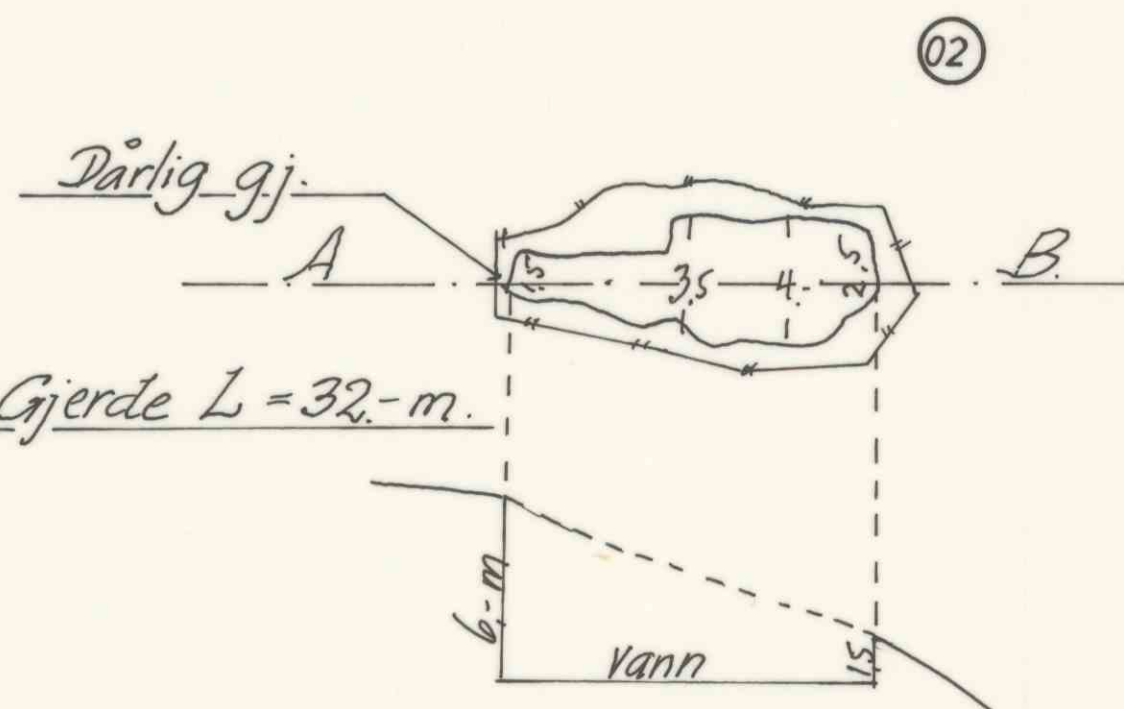
Dårlig gj.

Gjerde L=32.-m.

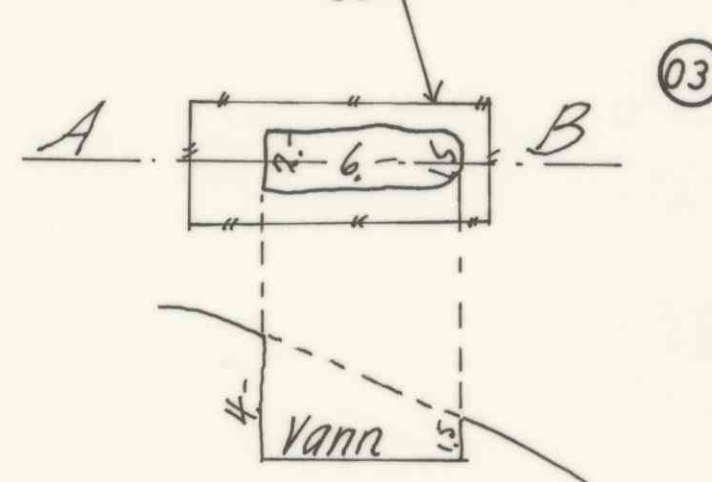
Dårlig gj. L=27.-m

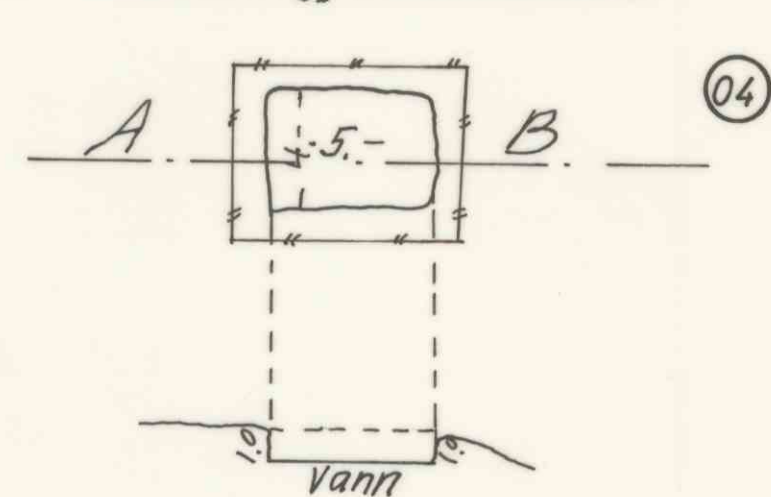
Inntakt gj. L=27.-m

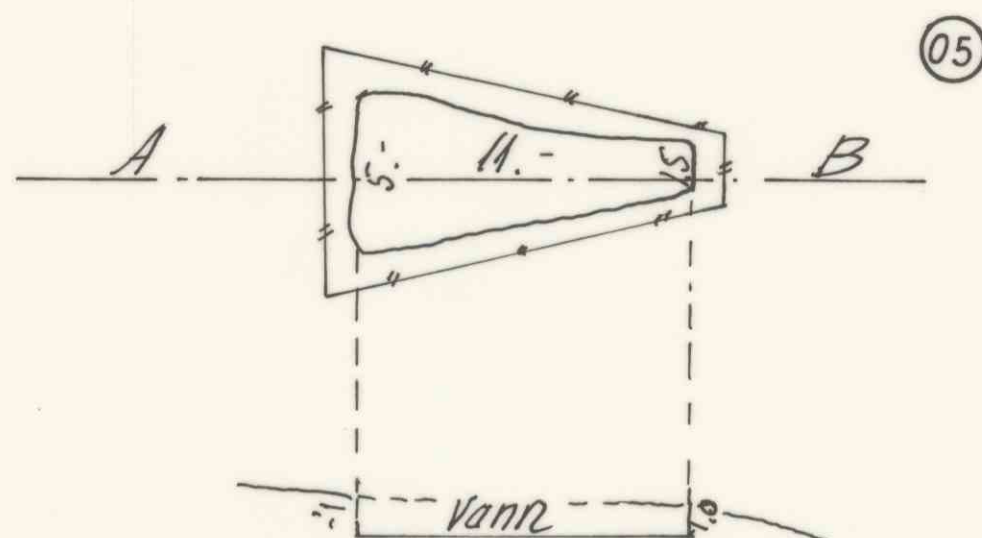
Defekt gj. L=36.-m

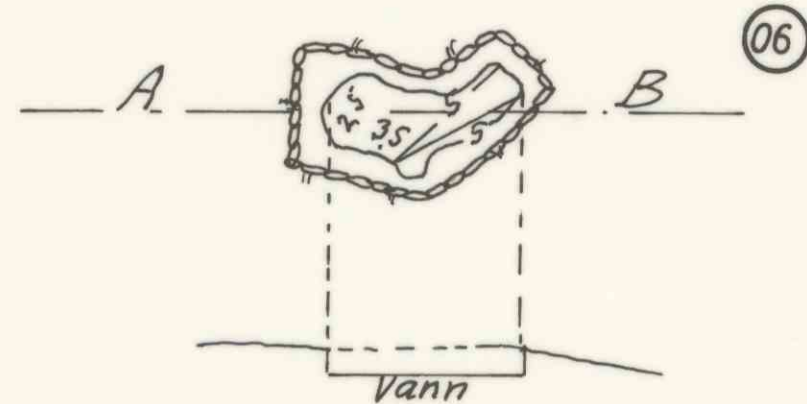
Gj. inntakt. på stengj. L=32.-m.

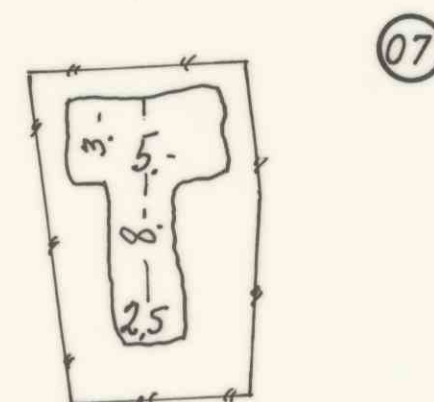
Dårlig gj. Vannfylt. Gj. L=38.-m

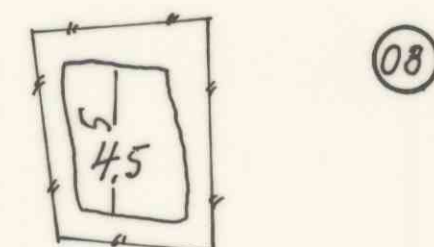
Dårlig gj. L=28.-m. Vannfylt

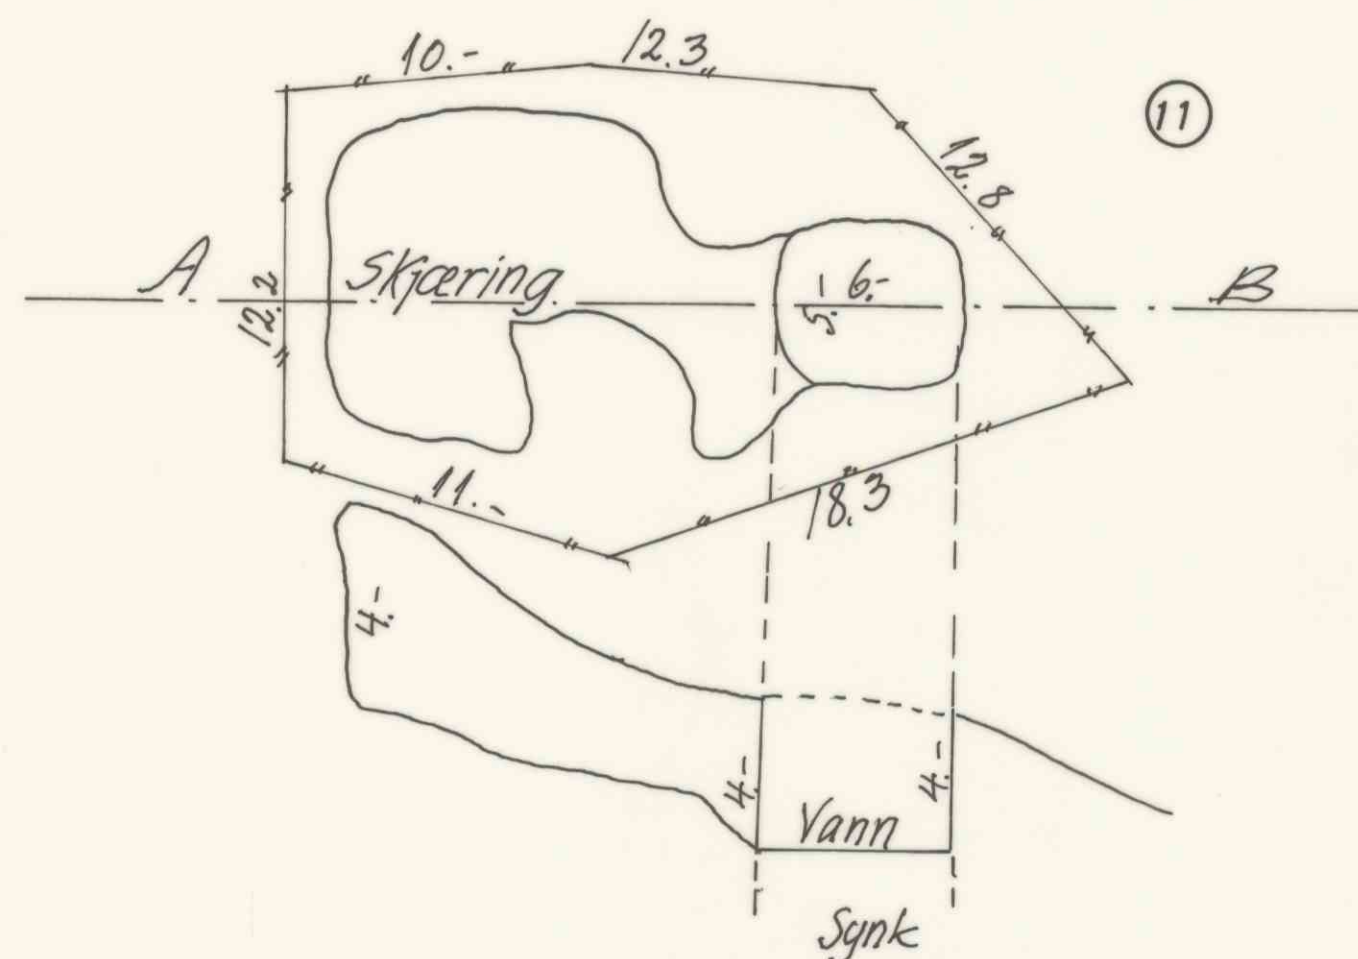
Gj. inntakt L=73.-m.

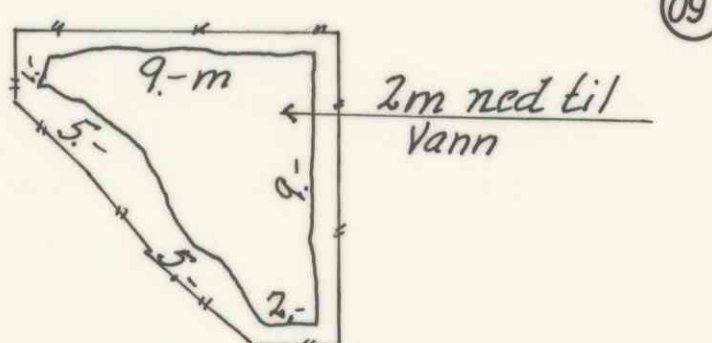
Gj. inntakt oppå stengj L=45.-m
